Colonial Parkway Reconstruction

Mega-Project* Profile: COLO Parkway Reconstruction

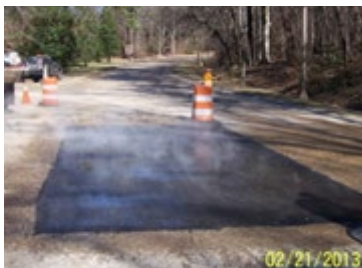
Above: Asphalt patches checkerboard the Parkway.

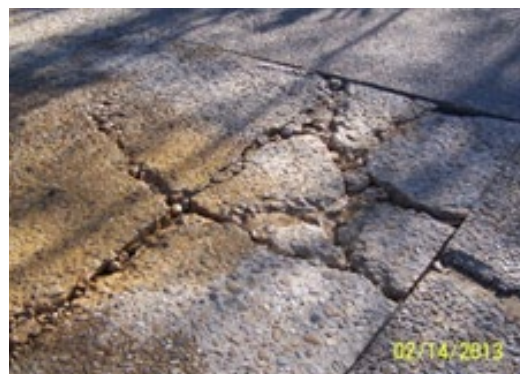
Middle bottom: Typical failed slab in high bus traffic area. Joint failure and slab cracking lead to water infiltration, pumping, and ultimate failure.

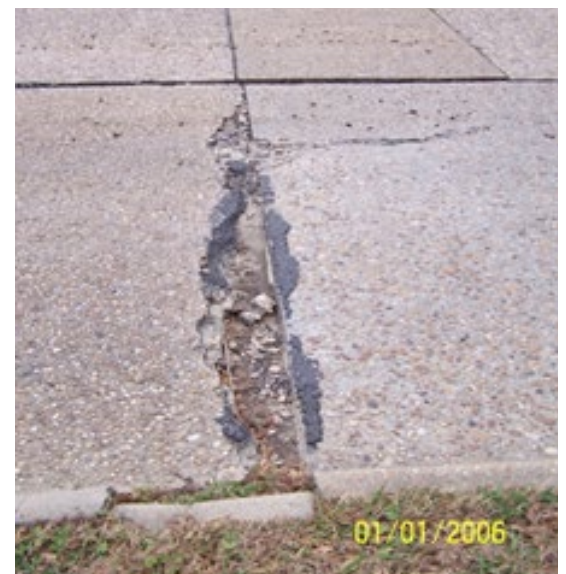
Right middle: Edge failure, patch failure, curb failure, joint sealant failure, cracked slab, slab settlement. High bus traffic area.
